SUBJECT: S-3 Narrative Report of Operational Mission 16, November 1943.

LOCALITY : RJUKAN

ATTACK ON HYDRO ELECTRIC POWER STATION AND CHEMICAL WORKS
AT RJUKAN, NORWAY ON 16.11.43.

S. A. 661
CHEMICAL WORKS
RJUKAN, NORWAY
16.11.43

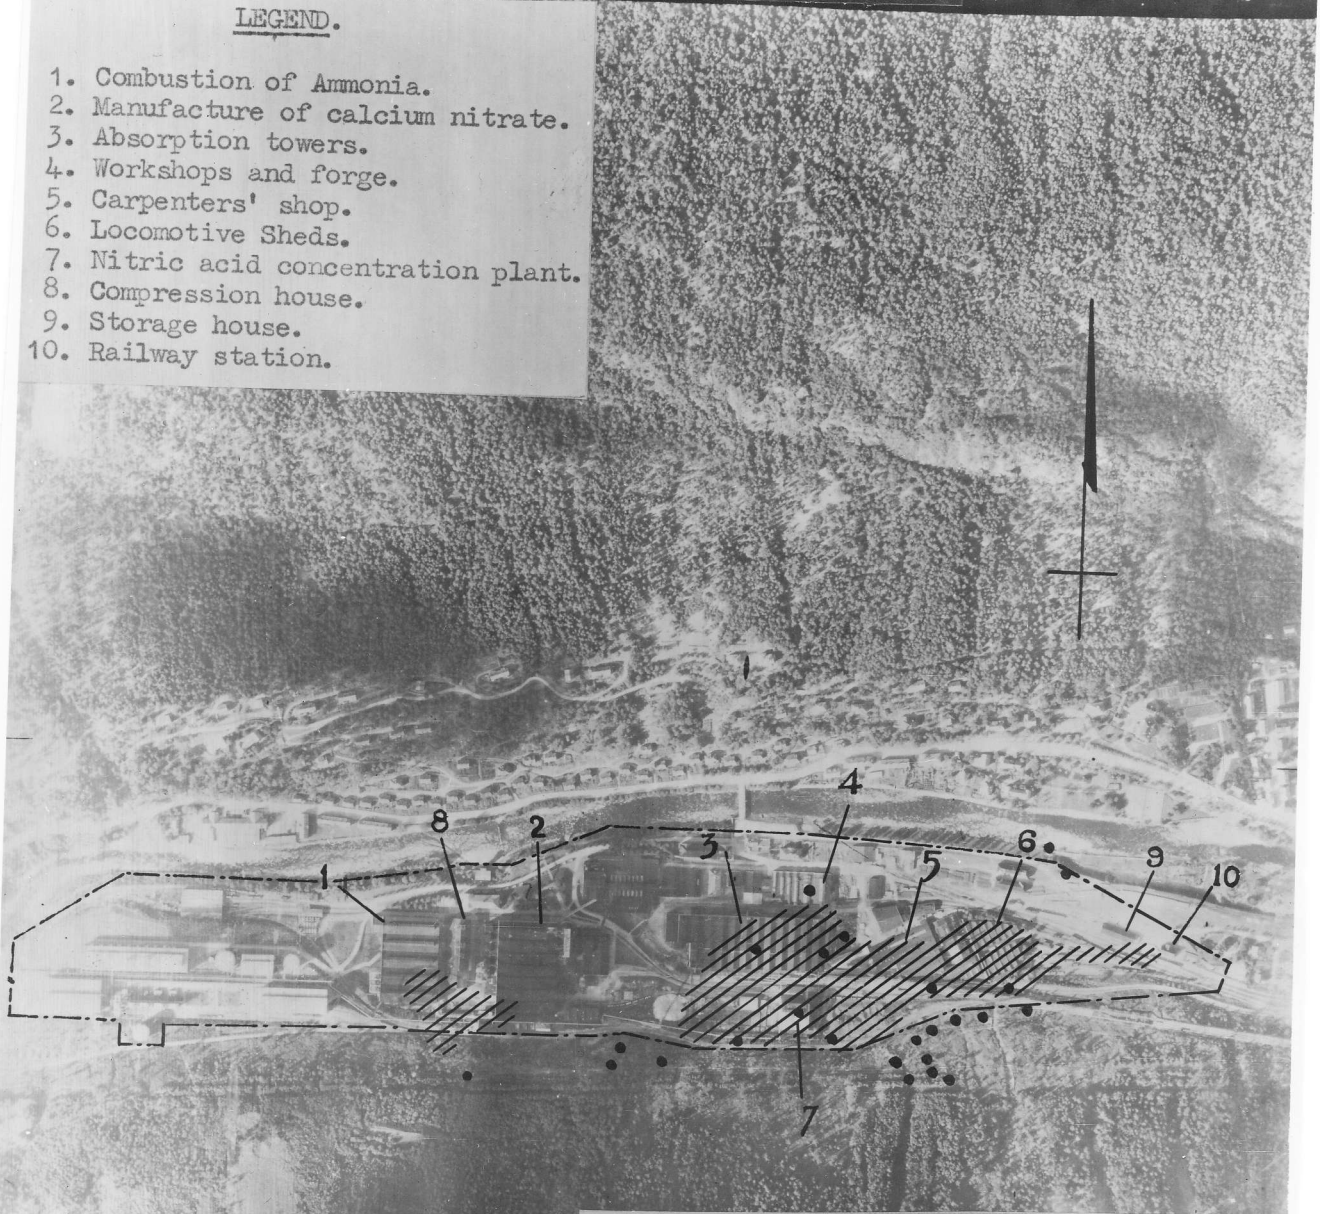
- (a) The majority of bursts seen are concentrated on and very near the Chemical Works. There are a number of direct hits on various buildings, but due to haze and smoke over this target also it is difficult to accurately plot many of these direct hits.
- (b) At least 1 direct hit can be seen on the Nitric Acid Concentration plant and 2 direct hits on the Absorption towers. 3 direct hits are observed on the Mechanical Workshops and forges.
- (c) A heavy concentration of bursts are seen across the Carpenters

- (d) Another concentration of bursts can be seen on the Combustion of Ammonia plant, Compression house and another unidentified building, with bursts extending in the wooded area to the South.

- (e) Scattered bursts are observed in the wooded area immediately South of the Locomotive sheds and two bursts can be seen on the banks of the river, just North of the Locomotive sheds.

- (v) ANNOTATED PRINT NO. 2 (SAV 392/8 No. 8)
- A. Shows a concentration of bursts on the Nitric Acid concentration plant and the Absorption towers.
- B. Shows another concentration of bursts across the Locomotive sheds, Carpenters shop, Rolling stock repair shop, Rjukan storage house and Rjukan railway station.
